# TEMPORAL PATTERNS OF LAND USE CHANGE IN MAIGANGA: A CASE STUDY OF THE EFFECTS OF MINING AND RECLAMATION

Land resources, ecological processes, and human development activities make land-use patterns a key indicator of environmental sustainability. The Maiganga coal field in Gombe State, Nigeria, presents a distinctive landscape where active mining has occurred alongside progressive reclamation efforts by Lafarge Africa and Ashaka Cement. This study assessed land-use and land-cover (LULC) changes in the area before mining, during extraction, and following reclamation over twenty years. The classification of multi-temporal Landsat imagery identified five major LULC categories: vegetation, farmland, bare surface, settlement, and water bodies. The results show distinct LULC transitions across the study timeline. Vegetation cover increased substantially after 2010, coinciding with ongoing reclamation and restoration practices. Farmland exhibited variable patterns influenced by shifting agricultural activity and land accessibility. Bare surfaces initially expanded during intensive mining but later decreased as stabilization and re-vegetation progressed. Water bodies increased mainly du

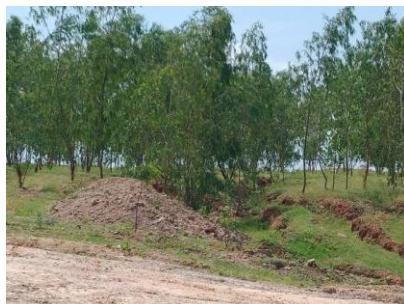
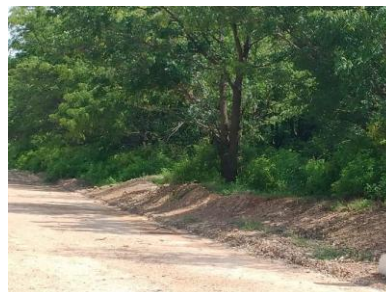
Plate 1. Tree Plantation established in 2021

Plate 2. Tree Plantation established in 2009

To mitigate soil degradation and air pollution from particulate discharge, tree-planting initiatives (Plate 1 & 2) were implemented. These trees and surrounding vegetation provided canopy cover and absorbed airborne dust particles, reducing pollutant spread. Additionally, soil integrity and structure were restored through natural processes such as root stabilization and leaf litter accumulation, which promoted soil aggregation and nutrient cycling (Plate 5).

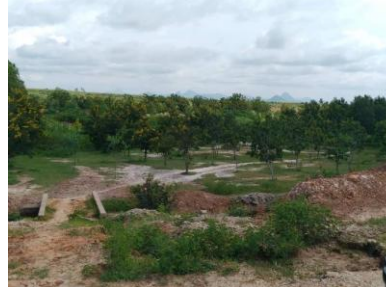
Plate 3. Artificial Wetland Afforestation area

Water-related impacts were also carefully managed. Wastewater and groundwater contamination were initially treated by constructing a sedimentation pond, which facilitated physical filtration (Plate 4). This was complemented by the creation of an artificial wetland (Plate 3) designed for phyto-depuration — a biological process that uses plants to remove contaminants — thereby enhancing water quality and supporting ecological recovery.

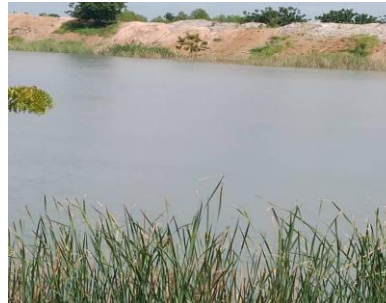
Plate 4. Sedimentation Pond

Moreover, the expansion of agricultural land outside the mining zones reflects a strategic adaptation to environmental conditions. Near-perennial water availability from mining-related hydrological alterations (Plate 4) has enabled off-season farming through irrigation, supporting food security and rural livelihoods.

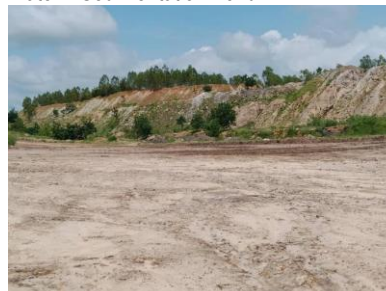
Plate 5. Reclaimed landfill area undergoing

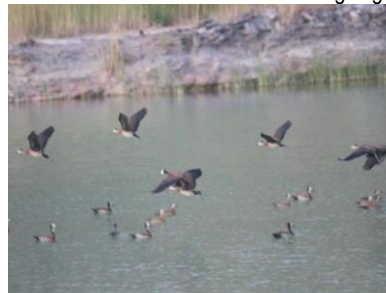
Plate 6. Active mine pond inhabited by White-forested and soil consolidation Face whistling ducks and other species of birds

One notable outcome is the emergence of wetlands, which has increased avian diversity and the settlement of water-dependent bird species (Plate 6) previously absent from the pre-mining landscape (Nsor & Nya, 2024; Nsor *et al.*, 2022). These avian interactions contribute significantly to ecosystem functions, including nutrient enrichment via fecal deposits on agricultural fields, as well as pollination and seed dispersal (Tela *et al.*, 2021). These findings underscore the interconnectedness of land cover dynamics and ecological health, emphasizing the need for informed, adaptive land management strategies.
